November 16, 2015

Re: ***Essroc San Juan Cement  
Compliance Evaluation Inspection, May 29, 2015 and  
Consent Decree (3 :09-cv-0 1578)  
Individual Permit No. PR0001163 and MSGP 2008 Tracking No. PRR05BJ45***

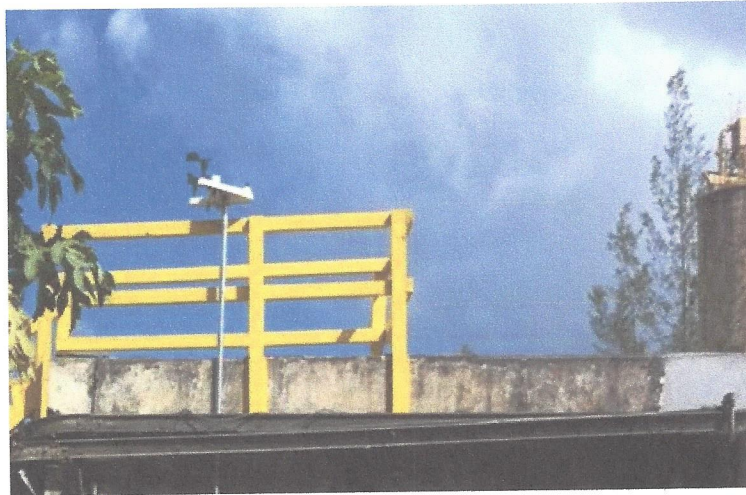
3. *"Essroc's rain gauge was said not to be working and instead were using the National Oceanic and Atmospheric Administration (NOAA) website to obtain precipitation data for the plant. As required by paragraph 14.a of the Consent Decree, Essroc is required to conduct precipitation monitoring on site and is therefore not complying with its obligations under the CD. Also, EPA was on-site on May 29, 2015 when there was an afternoon rain event. Essroc's precipitation log included in its Quarterly Report dated July 30, 2015 indicates that there was 0" of rain fall on May 29 and 1.63" on May 30, 2015. Please explain this discrepancy."*

Weather Station at Essroc San Juan

On 2012 ESJ acquired a weather station to be able to monitor rain data at the site. For unknown reasons the weather station was not installed before. The weather station was installed on top of the Technical Resources building on early August this year and was put in operation on August 14<sup>th</sup>. Rain data submitted on DMR reports after August 14<sup>th</sup> is data collected at the site by the weather station. We are including a picture of the weather station.

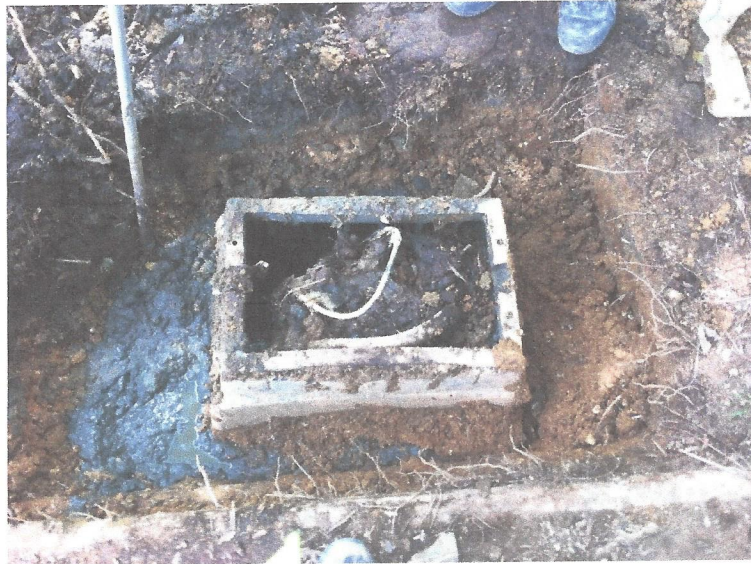
2. *"As shown in photos 2711 to 2714, there are potential water line leaks in the area shown in the photos, as well as behind the office building shown in photo 2751. Please identify if this is*

*a water line leak and confirm that this water is permitted to discharge to Outfall 001 (PR00001163)."*

Old Electrical Junction Box

ESJ dug the area near the box and couldn't find any leaking line that could be generating the water flow. The box looks to be an old electrical junction box and nothing related to water or any fluid. Water flow seems to be ground water coming out through that specific spot. However, on the following weeks after the inspection the water flow can no longer be seen going into the stormwater channel.

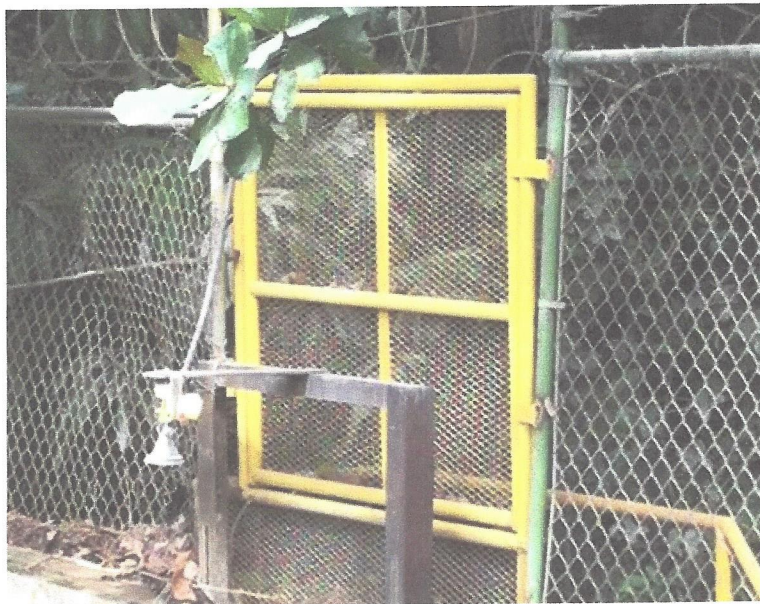
5. *"As shown in photographs 721 and 722, the cover on the ultrasonic sensor was missing and was covered with duct tape. The unit was working, but a new cover was said to be on order. Please provide to the EPA the status of the replacement of the ultrasonic sensor cover."*

Ultrasonic sensor with gate

Cover replacements for the sensor were ordered, received and replaced. In addition, ESJ built a gate at the sensor area to protect it from any outside vandalism. The gate remains locked at all times and a key is available with the security guard and at the environmental engineer's office.

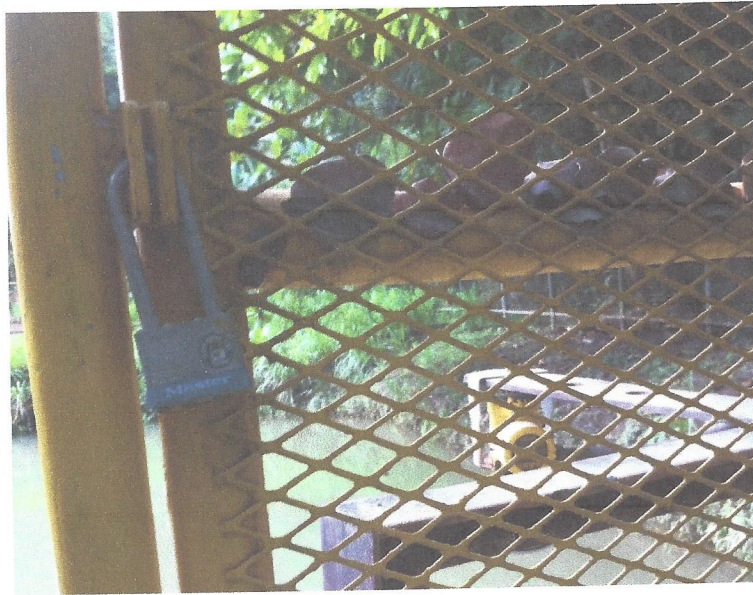
Lock at ultrasonic sensor gate

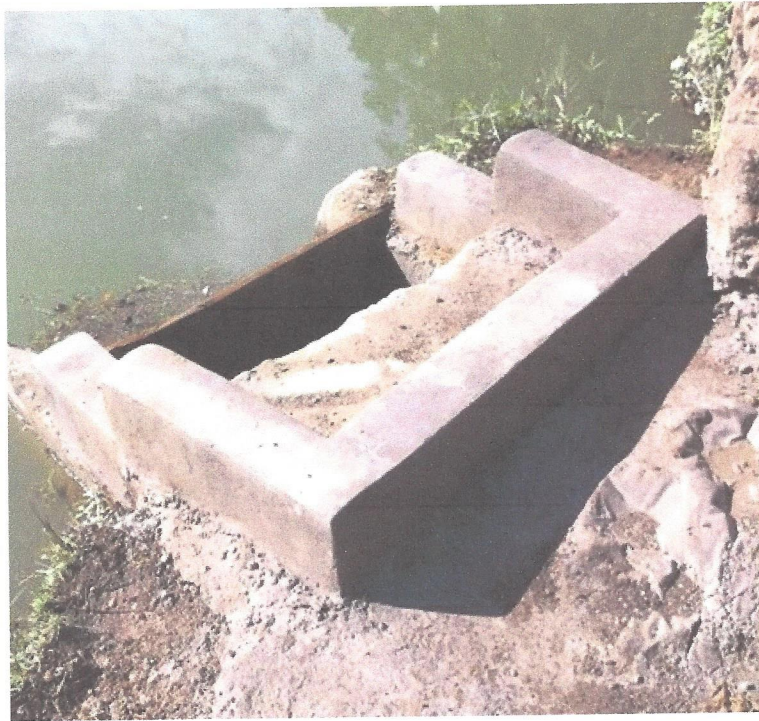
7. *"As shown in photos 772, 773, 776 and 777, during the inspection there was turbid water entering Pond No. 2 near the outlet prior to flowing under a roadway and flowing into a small pond prior to Outfall 001. The turbid stormwater was coming from a dirt roadway that runs along the northern and western side of Pond No.2 and along the western side of the gabion channel. Essroc should implement additional stormwater BMPs to address this turbid storm water flow since at the point of entry into Pond 2 it has very little time to settle out*

*before discharging to Outfall 001. As shown in Tables 1 and 2 above, there have been TSS violations in June, April and January of 2015 as well as October and December 2014.”*

Modification of Lagoon 2 to Outfall 001

ESJ has already started to modify areas around the settling ponds to prevent as much as possible that runoff may gain access to the outfall point without entering any of the settling ponds. We are including pictures of some of the modifications that will help to prevent water to discharge without going to the settling ponds.

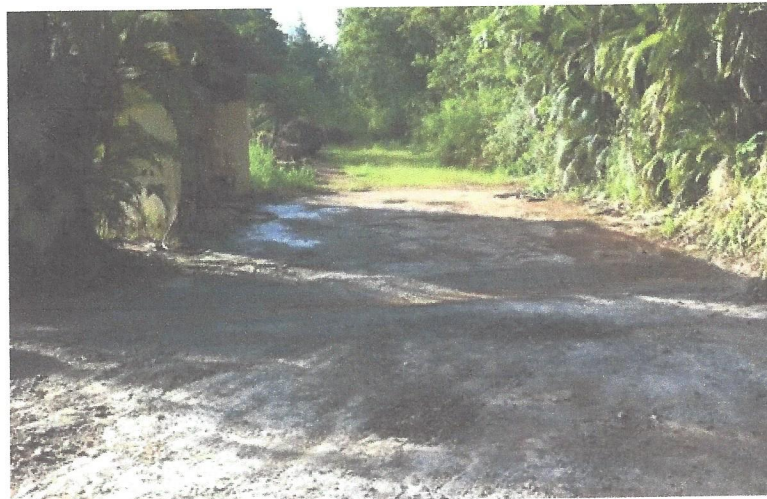
Swale to route runoff to Lagoon 2

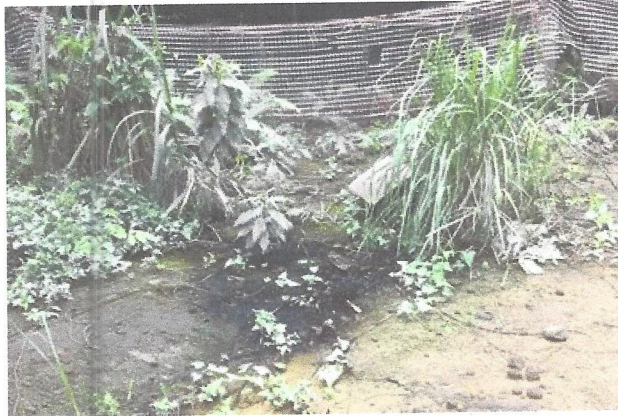
#### **Control Room Septic System**

During the course of 2015, ESJ has been modifying some of the septic systems because it has been found that stormwater runoff can actually get into a septic tank and overflow it during a rain event. Small modifications have taken effect to basically raise manhole level

Before

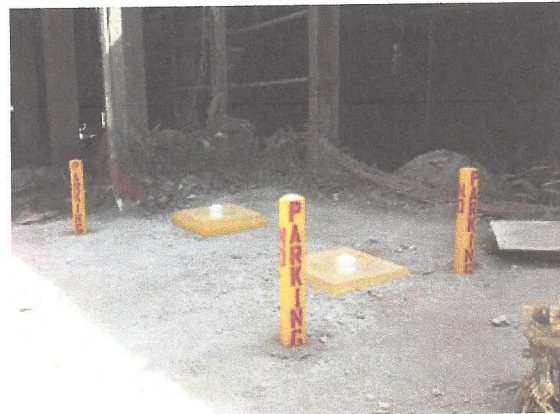
After

from ground and prevent stormwater runoff from draining into the septic tanks with the potential to overflow it.

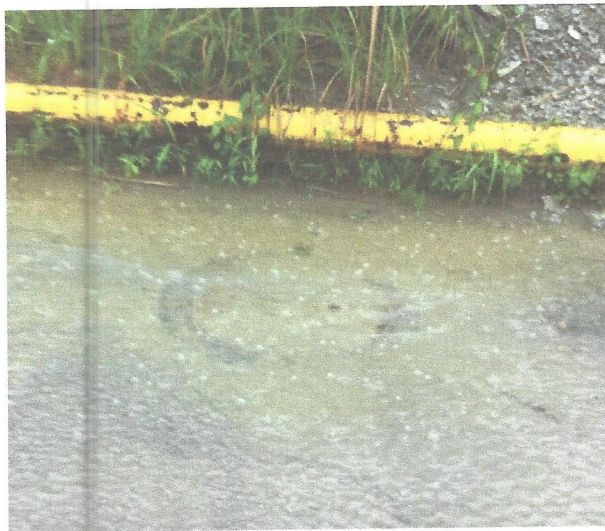
#### **Packing House Septic Tank**

Before

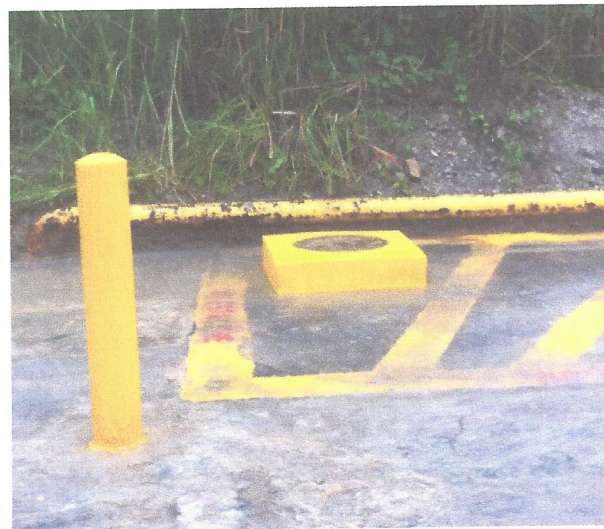
After
